Inspection Report

Property Address:
33977 Stara Lane
Hendersonville NC

HomeBuyers Inspection HBI

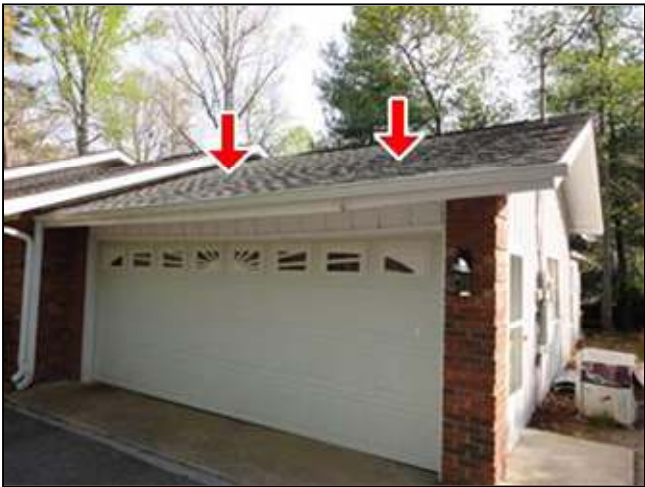
1.0 Item 1(Picture)

(1) Evidence of a leak in the Den below corresponds with the middle skylight roof and flashing area. Repairs are needed. Recommend a qualified contractor inspect further and repair as needed.
-

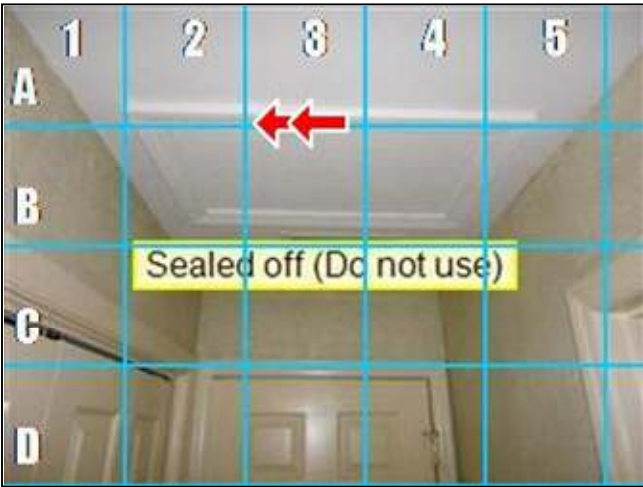
1.5 Item 1(Picture)

No longer an attic access. Use the pull down stairs at garage.

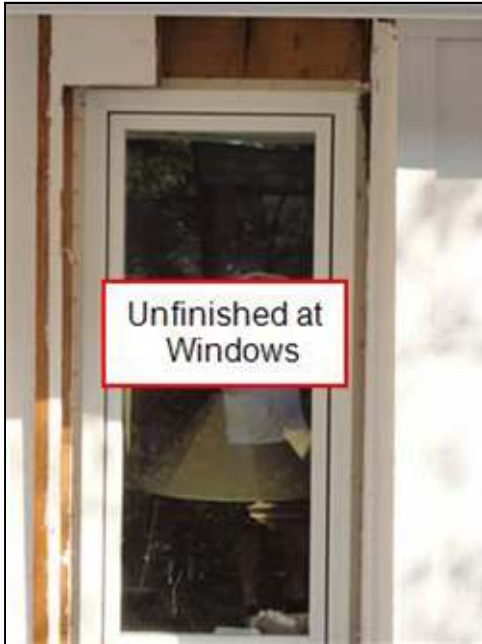
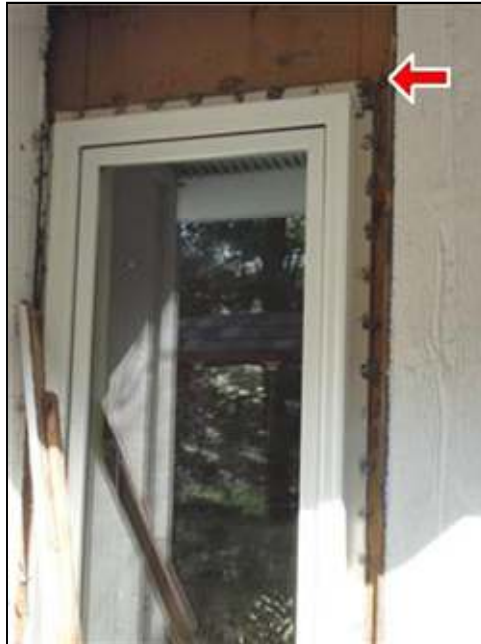
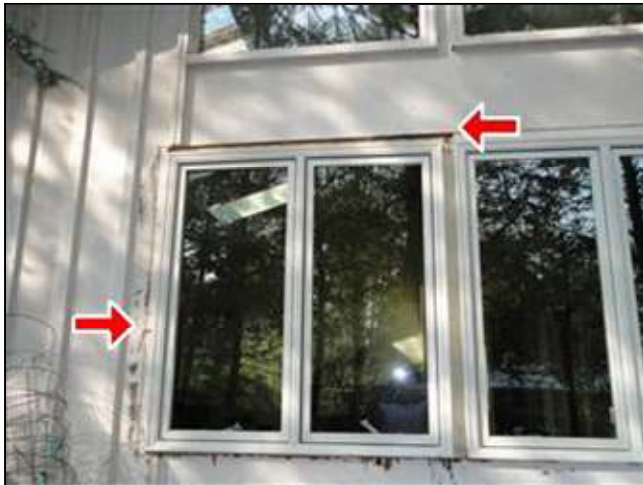
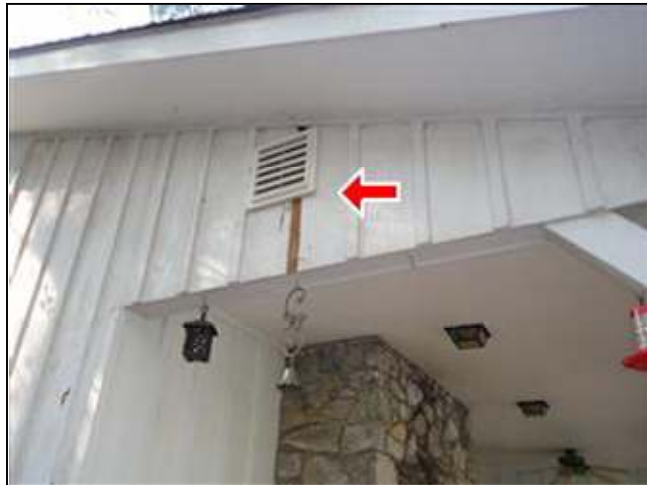
2.0 Item 1(Picture)

- 🔧 The Wood siding at the right side (facing front) and rear of home is missing or incomplete at time of inspection around new premium windows that have recently been installed. I did not inspect the installation of siding at this location. A qualified contractor should inspect and repair as needed. The siding will need prep and paint.

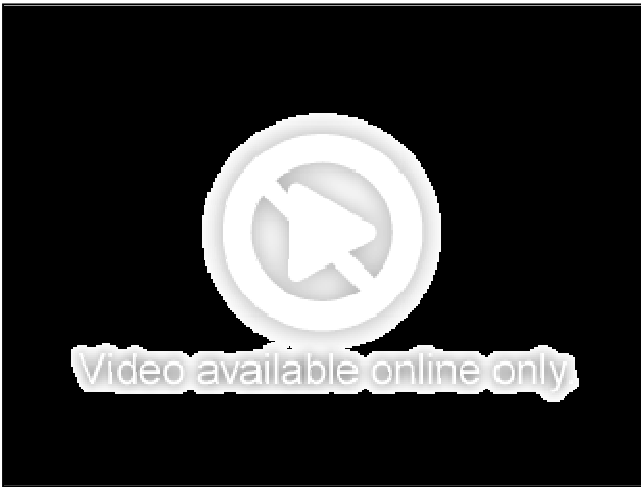
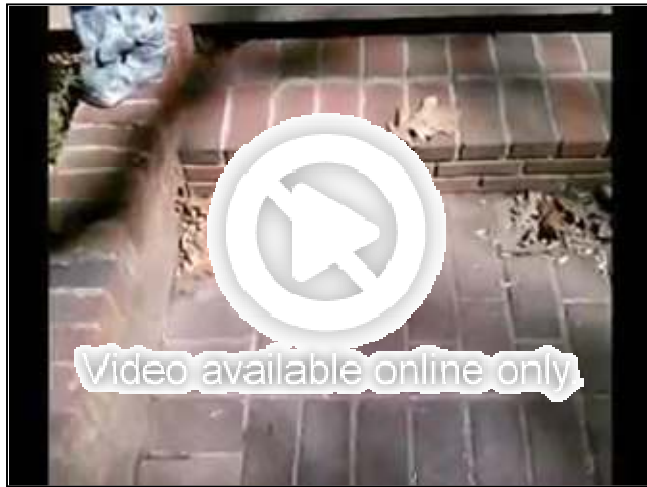
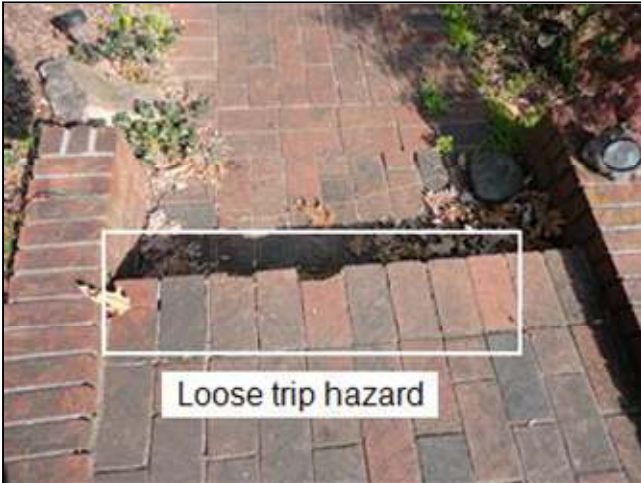
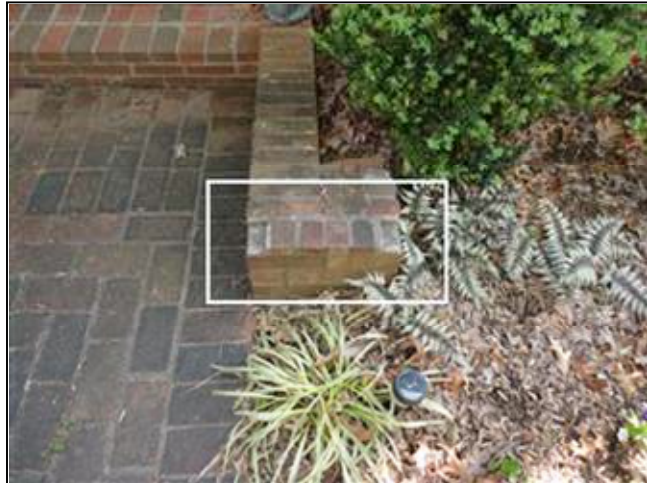
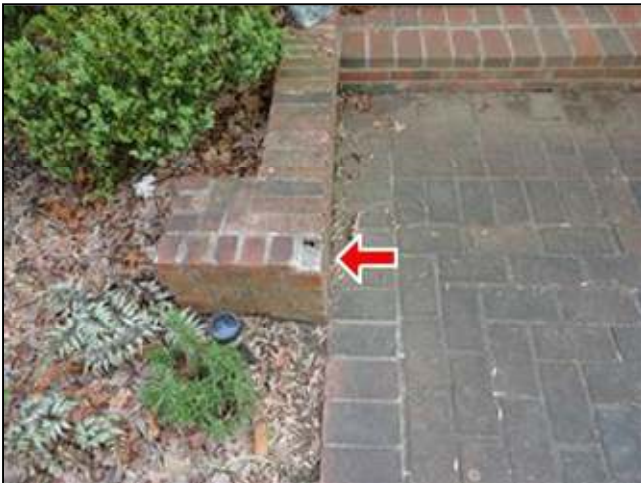
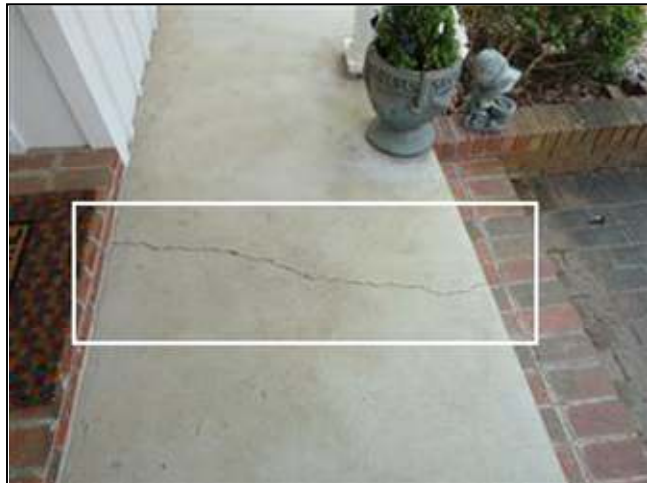
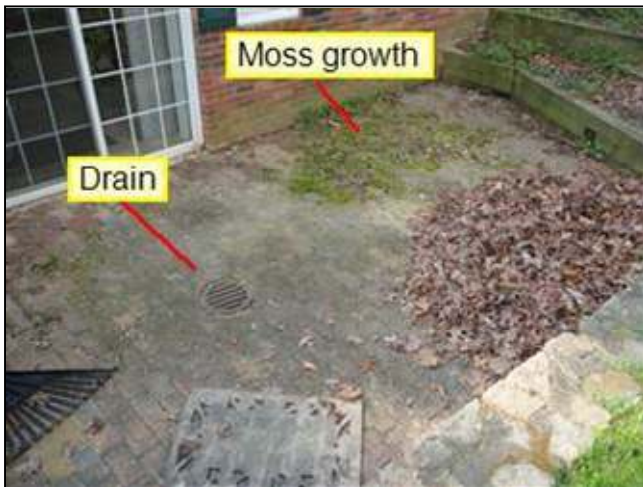
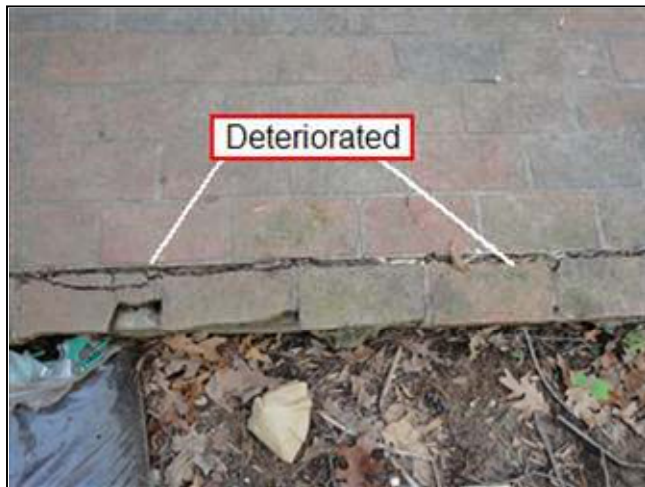
2.4 Item 1(Video)

- 🔧 (1) Possible water run-off from the street into driveway during rain. I am unable to determine the frequency or amount.
- 🔧 (2) The brick walkway at the front of home are deteriorated in areas. A general replacement is likely. A qualified contractor should inspect and repair as needed.
- (3) Concrete is cracked at front entrance of home. Appears to only affect the slab itself and is more cosmetic.
- 🔧 (4) The brick floor on the patio at the left side (facing front) has deteriorated mortar or grout, and is loose and uneven in areas. Water can cause further deterioration if not repaired and sealed properly. A qualified contractor should inspect and repair as needed.
- 🔧 (5) The brick floor on the patio at the rear of home is old and deteriorated. A general replacement is likely. A qualified contractor should inspect and repair as needed.

2.4 Item 2(Video) Water signs at front step

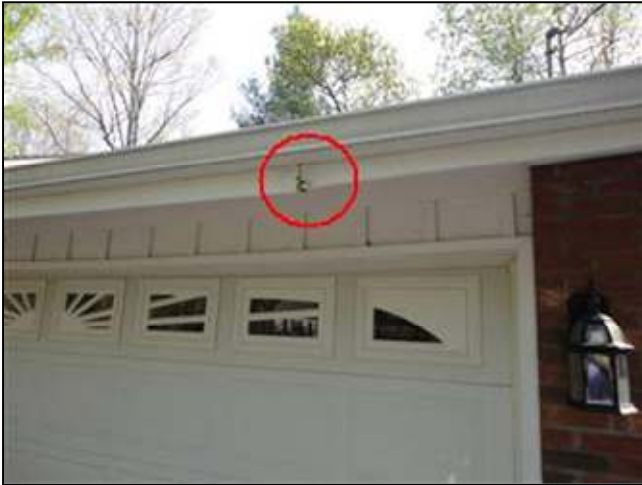
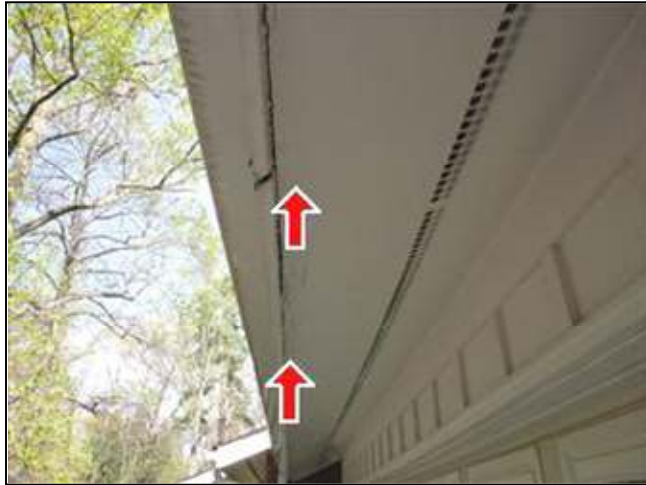
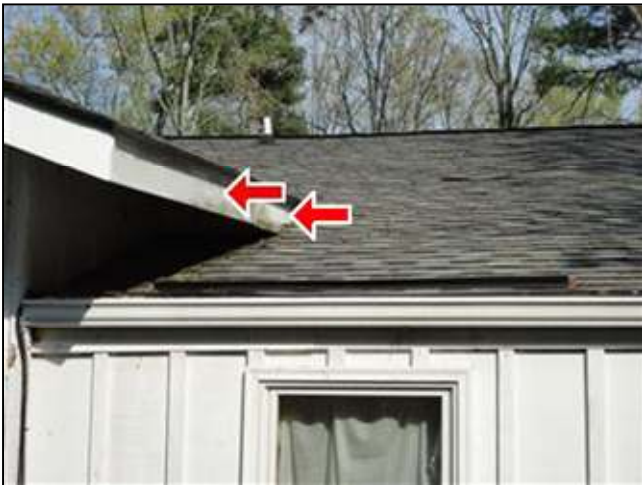
2.5 Item 1(Picture)

- 🔧 (1) The wood fascia and soffit panels at eave on the front of home above garage are deteriorated. Repairs are needed to roof covering as well. A qualified contractor should inspect and repair as needed.
- 🔧 (2) The wood fascia at eave on the right side (facing front) is deteriorated. This is a small repair. A qualified contractor should inspect and repair as needed.

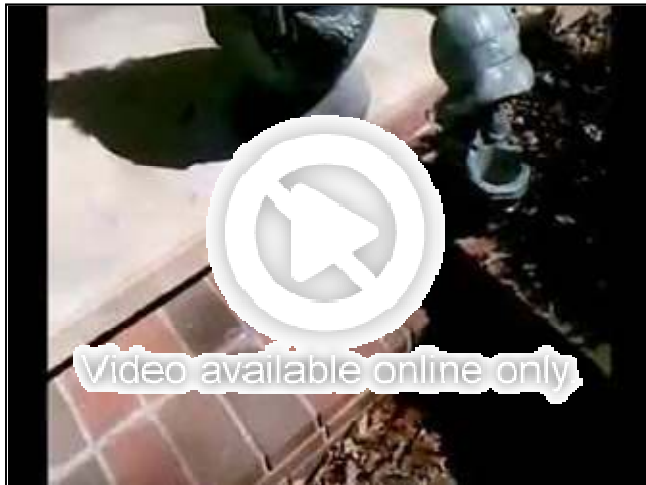
2.8 Item 1(Video)

Possible bees nest forming at right corner of front steps (see video)

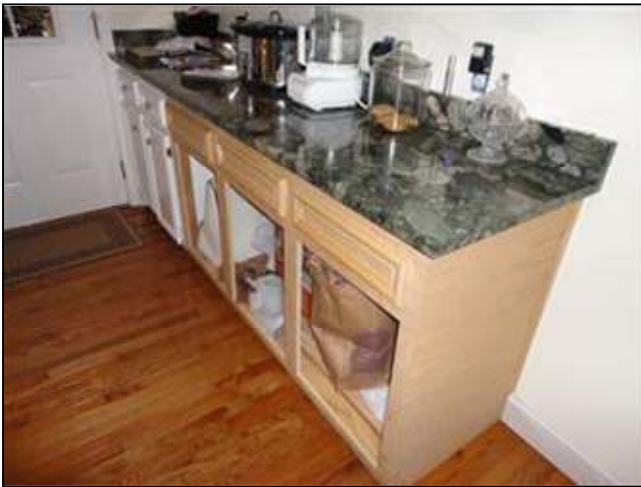
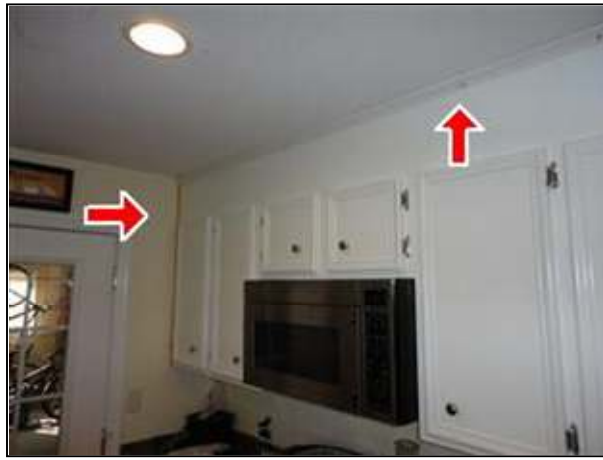
4.5 Item 1(Picture)

Base Cabinetry and trim at wall cabinet are unfinished at kitchen.

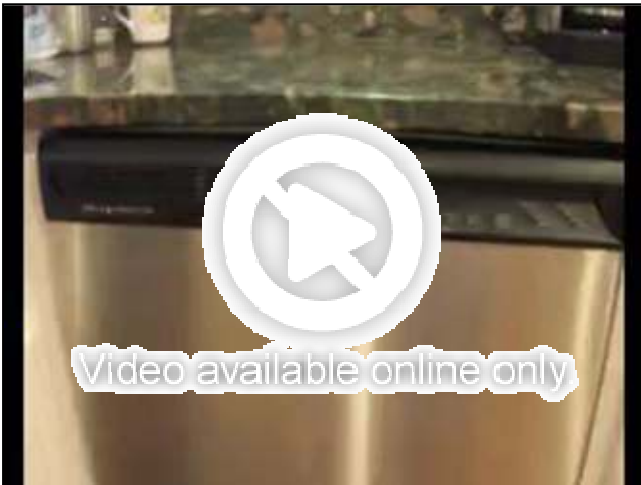
4.9 Item 1(Video)

The dishwasher is loose and needs securing to underside of countertop (using a proper length screw). I recommend repair as necessary.

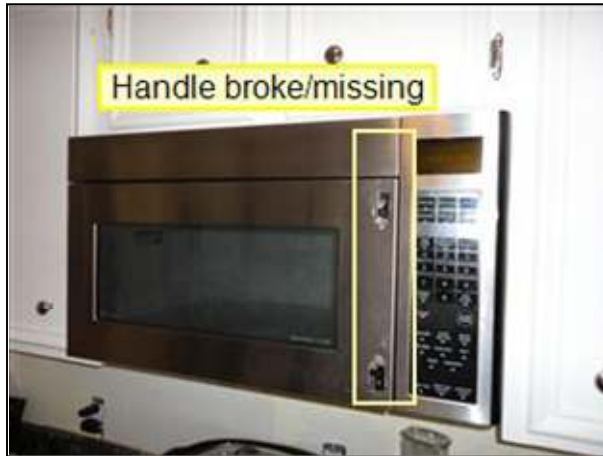
4.14 Item 1(Picture)

The microwave door handle is broken. I recommend repair as needed.

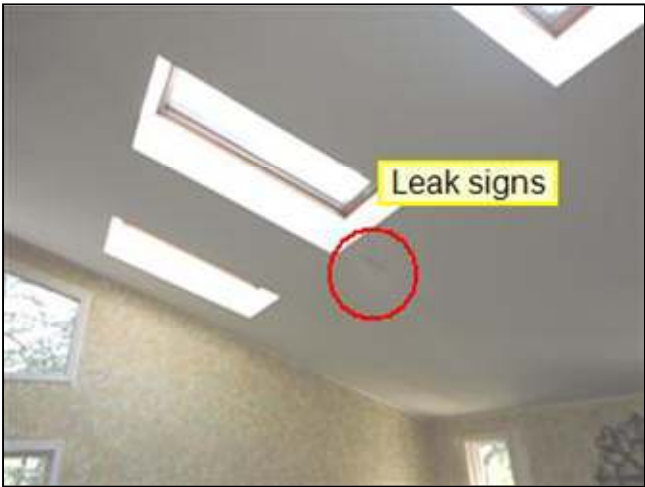
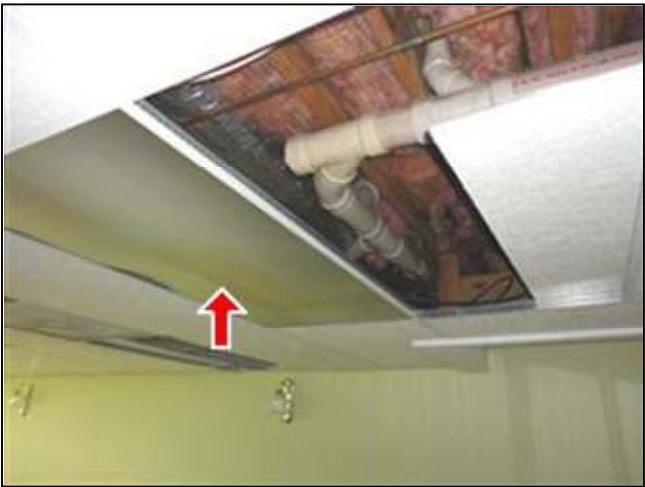
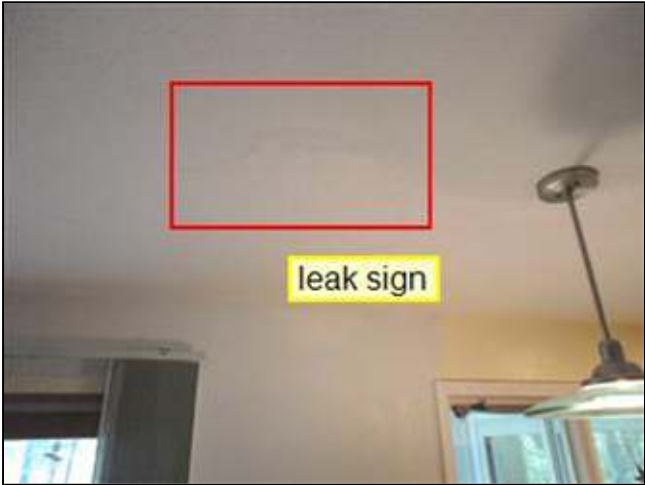
5.0 Item 1(Picture)

- 🔧 (1) The Sheetrock on the ceiling reveals a water stain indicating a leak did or still exists at the Den. Repairs are needed. A qualified contractor should inspect and repair as needed (See Roof Coverings).
- 🔧 (2) Water stain on ceiling panel lower level indicates plumbing leak.
- 🔧 (3) The Drywall on the ceiling reveals a water stain indicating a leak did or still exists at the Dining Room. Repairs are needed. A qualified contractor should inspect and repair as needed.

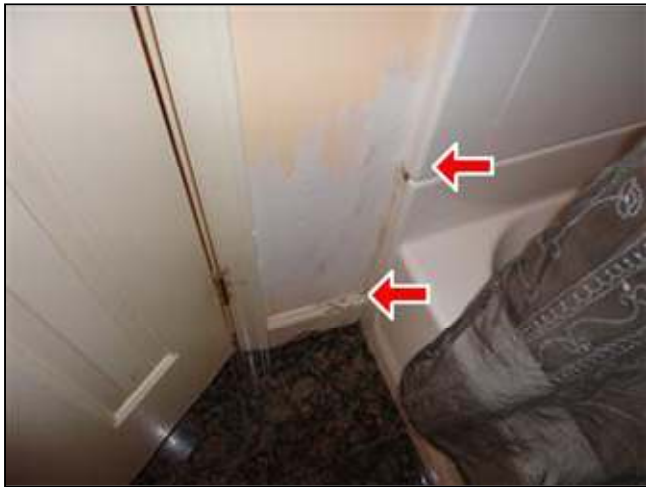
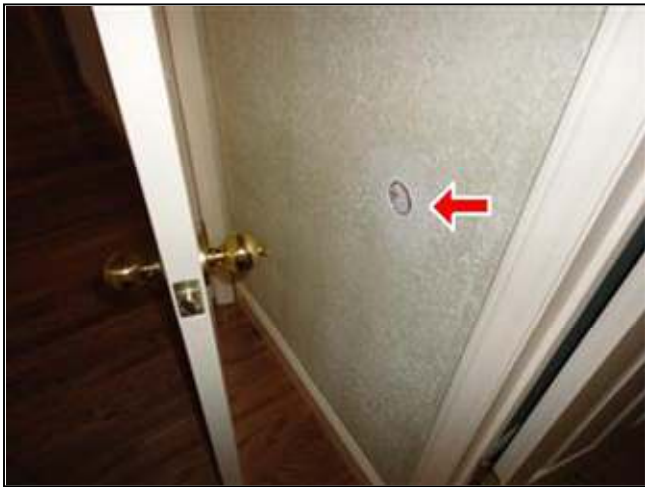
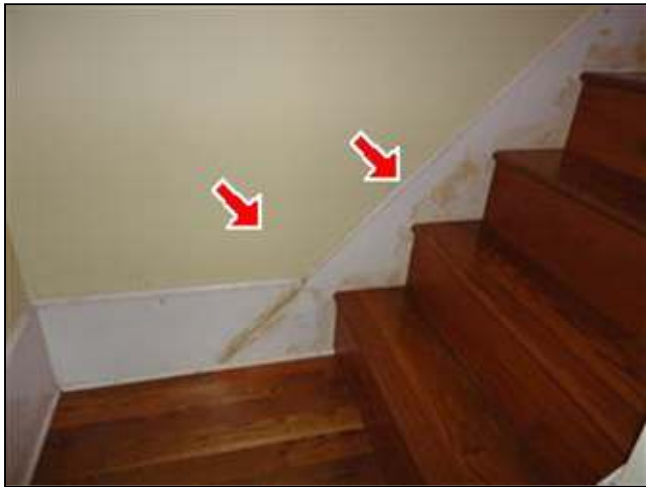
5.1 Item 1(Picture)

- 🔧 (1) Unfinished around windows in kitchen, and Den.
- 🔧 (2) The Wall at the bathtub is deteriorated and needs repair or replacement. The wall board and framing may need repair (not visible). I recommend repair or replace using a qualified contractor.
- 🔧 (3) The sheetrock on the wall is dented or damaged from door knob at the hallway. While this damage is cosmetic, it needs to be repaired. A qualified contractor should inspect and repair as needed.
- 🔧 (4) Stair cover trim is unfinished needs prep and paint at stairs.

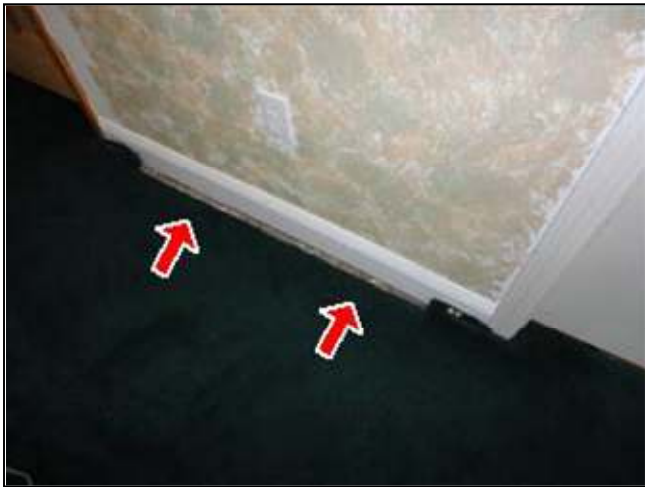
5.2 Item 1(Picture)

- 🔧 Carpet is loose or cut short from where electric baseboard use to be in areas around the perimeter of the Den.

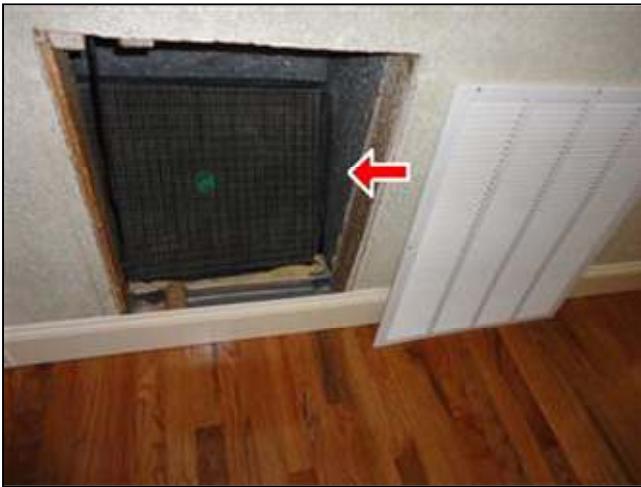
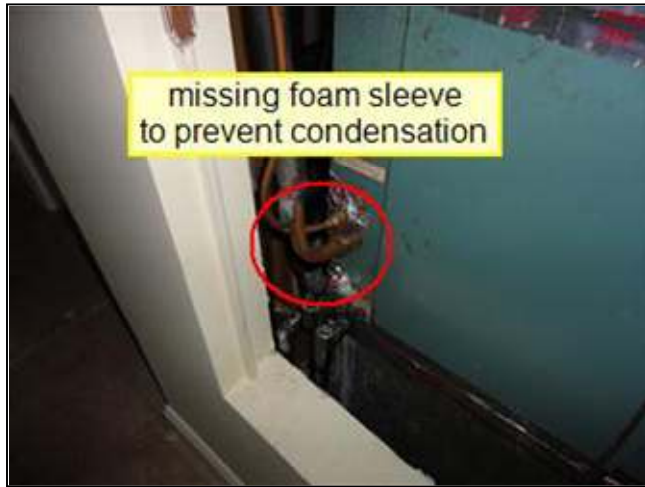
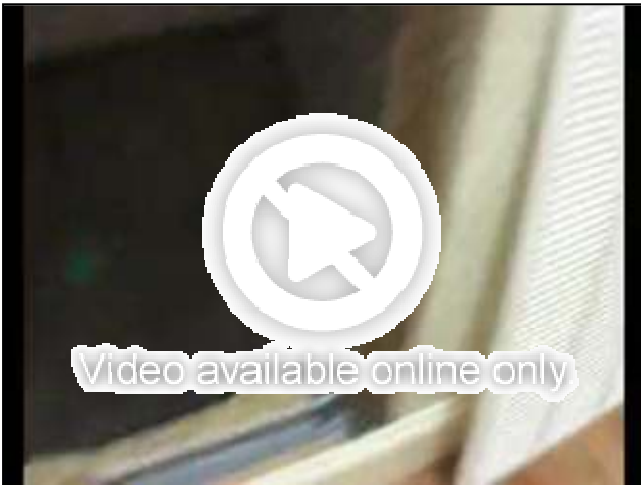
10.3 Item 1(Picture)

The washable filter is dirty. The filter needs to be cleaned. Recommend foil taping the filter for a better seal. See Video. Foam sleeve missing at suction line creates condensation and drips water.
