Inspection Report

Property Address:
33977 Stara Lane
Hendersonville NC

HomeBuyers Inspection HBI

Date: 3/30/2012	Time:	Report ID: 33977staralane
Property: 33977 Stara Lane Hendersonville NC	Customer: Danica Sample	Real Estate Professional: Victor Tate Victor Realty

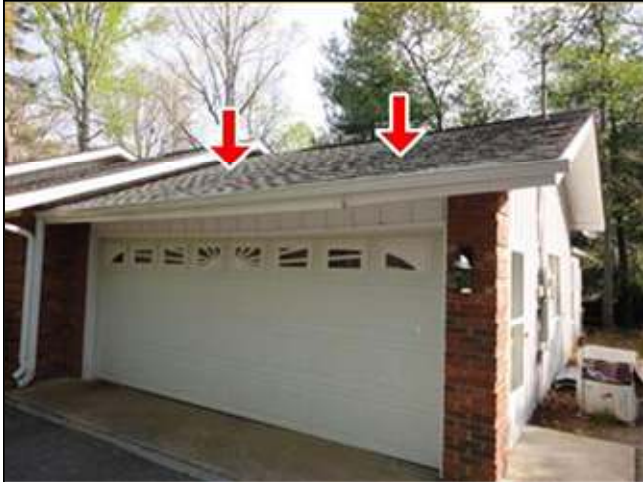
1.0 Item 1(Picture)

🔧 **1.0** (1) Evidence of a leak in the Den below corresponds with the middle skylight roof and flashing area. Repairs are needed. Recommend a qualified contractor inspect further and repair as needed.

🔧 **1.0** (2) The roof covering was installed improperly above garage. Roof sheathing needs to be replaced in this area. This will involve some shingle replacement. A qualified contractor should inspect and repair as needed.

(1) Evidence of a leak in the Den below corresponds with the middle skylight roof and flashing area. Repairs are needed. Recommend a qualified contractor inspect further and repair as needed.
-

(2) The roof covering was installed improperly above garage. Roof sheathing needs to be replaced in this area. This will involve some shingle replacement. A qualified contractor should inspect and repair as needed.

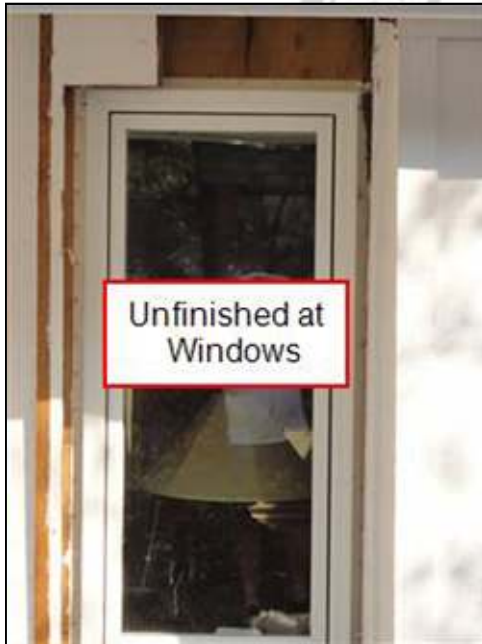
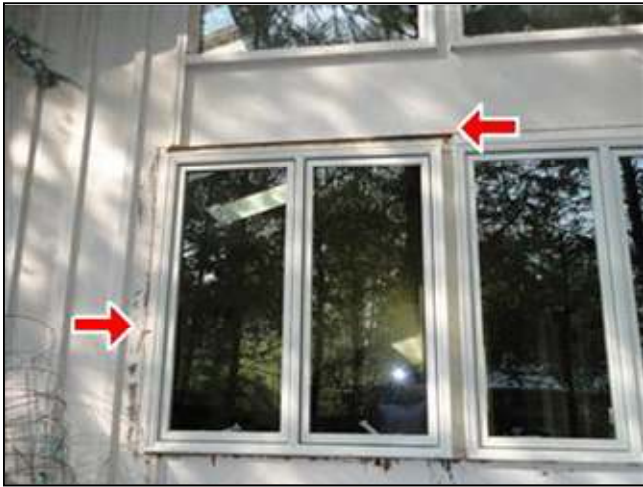
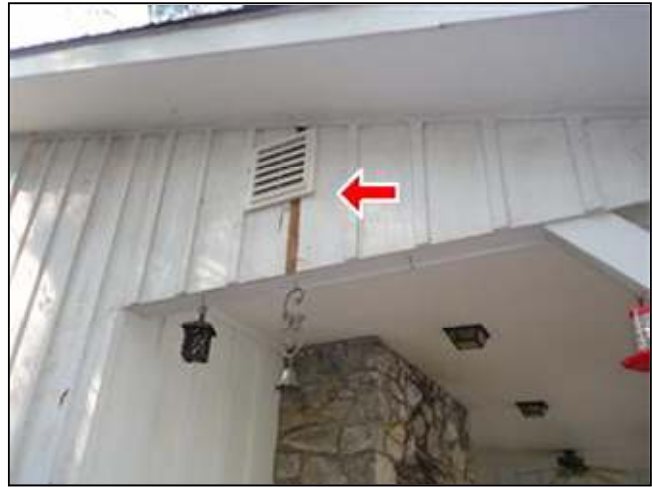
🔧 **2.0** The Wood siding at the right side (facing front) and rear of home is missing or incomplete at time of inspection around new premium windows that have recently been installed. I did not inspect the installation of siding at this location. A qualified contractor should inspect and repair as needed. The siding will need prep and paint.

The Wood siding at the right side (facing front) and rear of home is missing or incomplete at time of inspection around new premium windows that have recently been installed. I did not inspect the installation of siding at this location. A qualified contractor should inspect and repair as needed. The siding will need prep and paint.

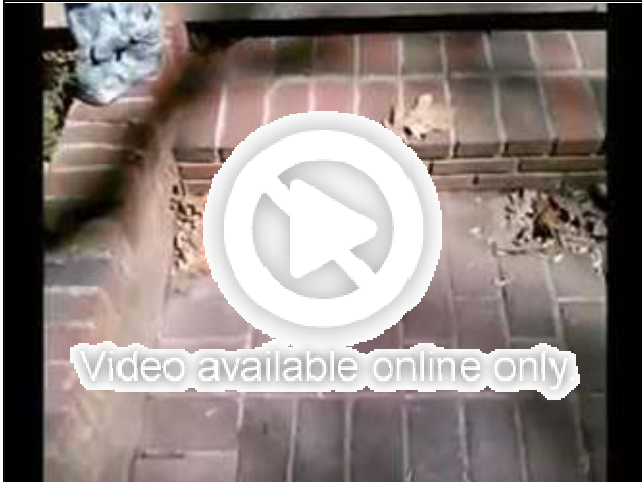
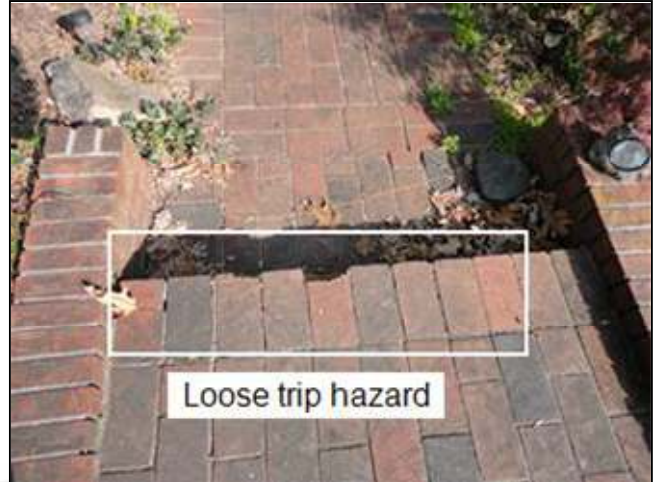
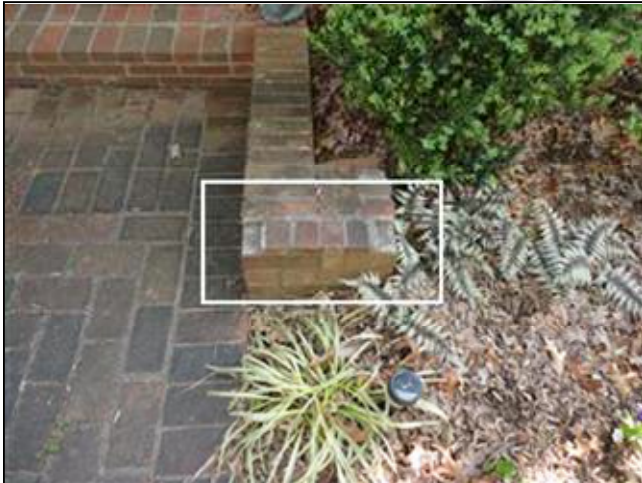
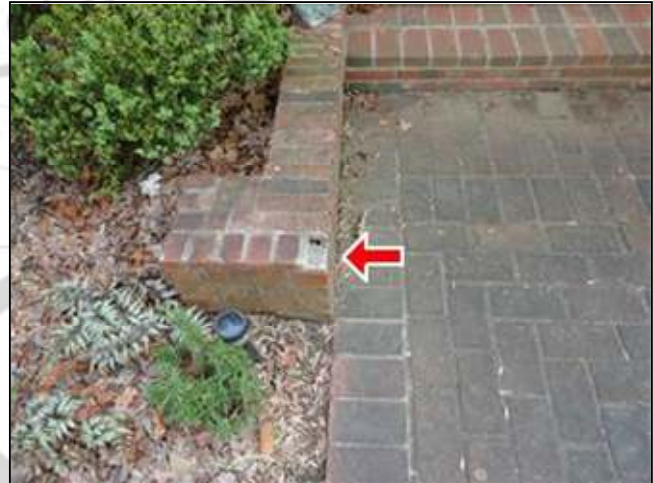
2.4 Item 2(Video) Water signs at front step

2.4 (2) The brick walkway at the front of home are deteriorated in areas. A general replacement is likely. A qualified contractor should inspect and repair as needed.

(2) The brick walkway at the front of home are deteriorated in areas. A general replacement is likely. A qualified contractor should inspect and repair as needed.
-

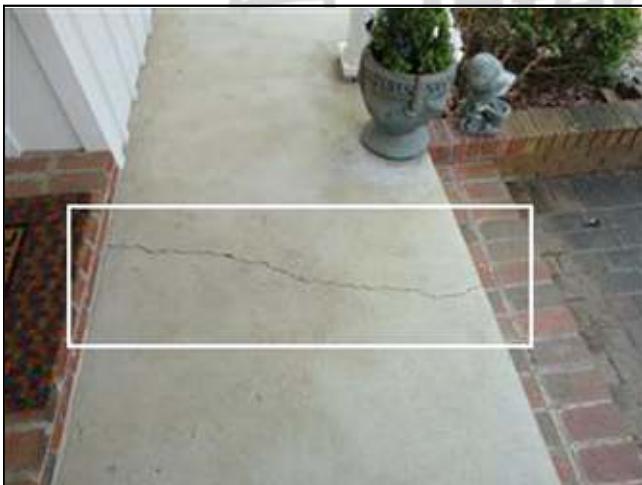
2.4 Item 6(Picture)

2.4 (3) Concrete is cracked at front entrance of home. Appears to only affect the slab itself and is more cosmetic.

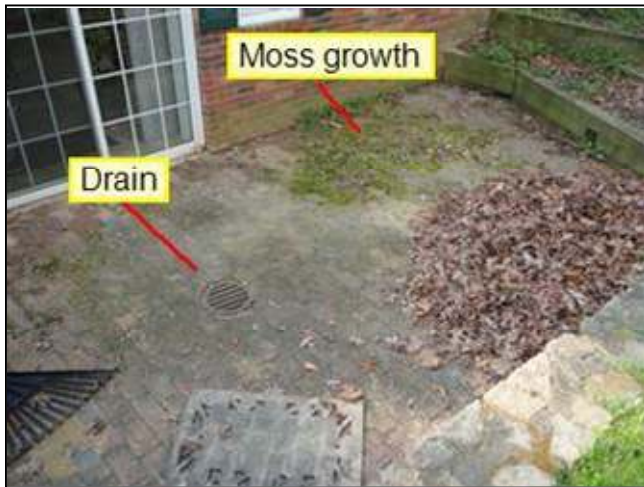
2.4 Item 7(Picture)

🔧 **2.4 (4)** The brick floor on the patio at the left side (facing front) has deteriorated mortar or grout, and is loose and uneven in areas. Water can cause further deterioration if not repaired and sealed properly. A qualified contractor should inspect and repair as needed.

(4) The brick floor on the patio at the left side (facing front) has deteriorated mortar or grout, and is loose and uneven in areas. Water can cause further deterioration if not repaired and sealed properly. A qualified contractor should inspect and repair as needed.
-

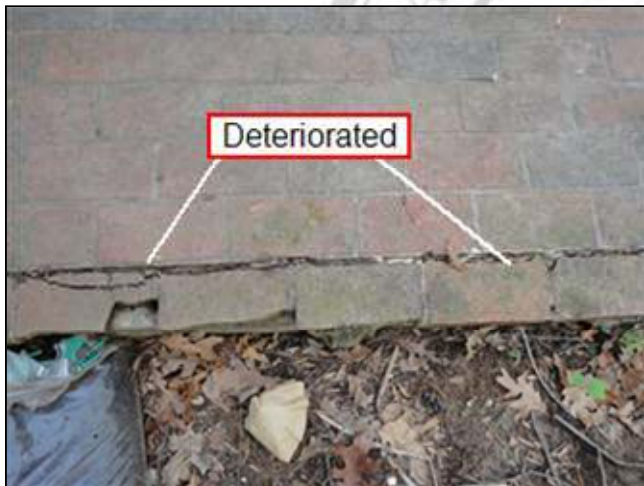
2.4 Item 8(Picture)

🔧 **2.4 (5)** The brick floor on the patio at the rear of home is old and deteriorated. A general replacement is likely. A qualified contractor should inspect and repair as needed.

(5) The brick floor on the patio at the rear of home is old and deteriorated. A general replacement is likely. A qualified contractor should inspect and repair as needed.

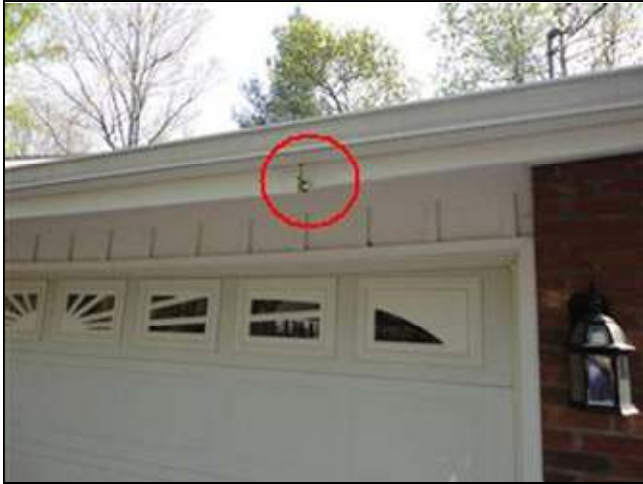
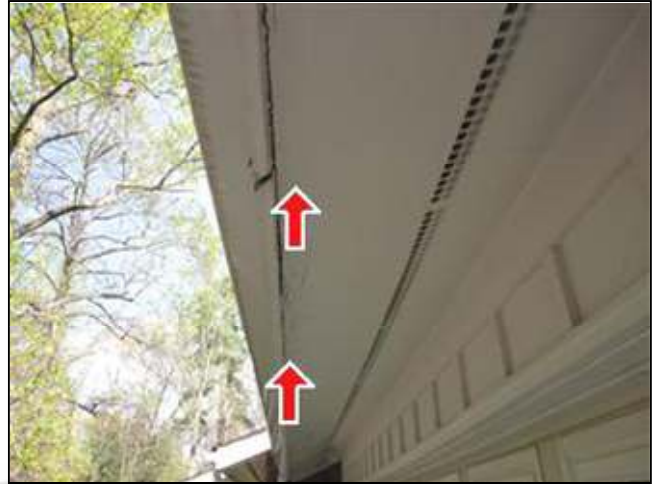
**2.5 (1)** The wood fascia and soffit panels at eave on the front of home above garage are deteriorated. Repairs are needed to roof covering as well. A qualified contractor should inspect and repair as needed.

(1) The wood fascia and soffit panels at eave on the front of home above garage are deteriorated. Repairs are needed to roof covering as well. A qualified contractor should inspect and repair as needed.
-

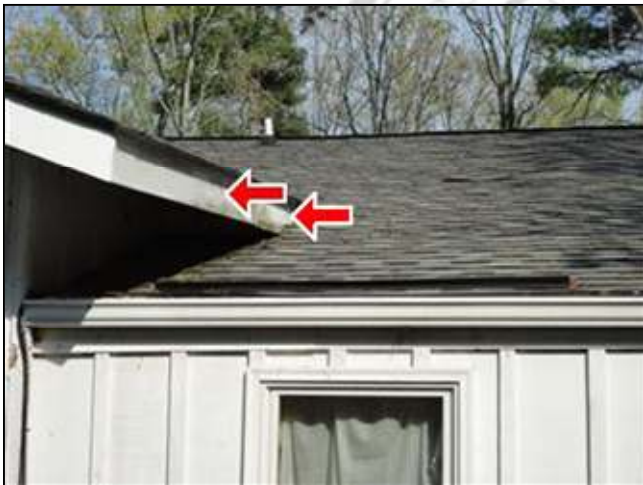
2.5 Item 3(Picture)

**2.5 (2)** The wood fascia at eave on the right side (facing front) is deteriorated. This is a small repair. A qualified contractor should inspect and repair as needed.

(2) The wood fascia at eave on the right side (facing front) is deteriorated. This is a small repair. A qualified contractor should inspect and repair as needed.

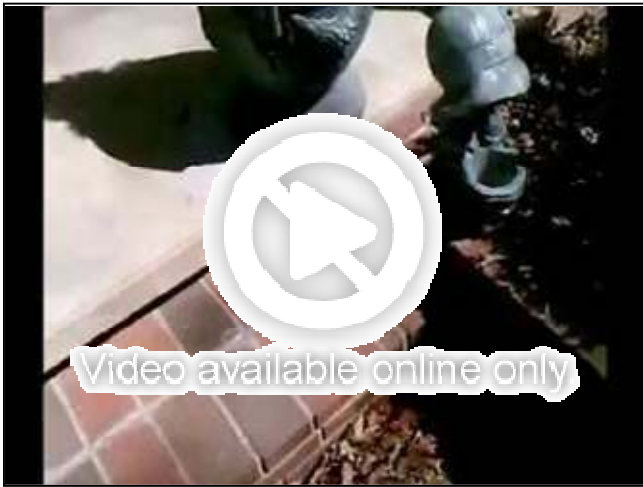
2.8 Item 1(Video)

2.8 Possible bees nest forming at right corner of front steps (see video)

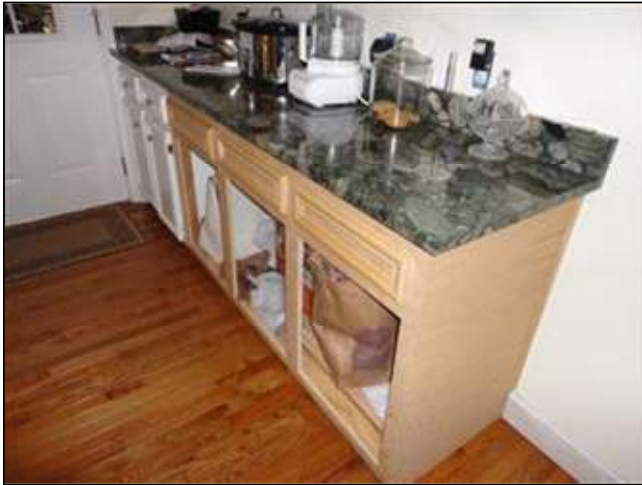
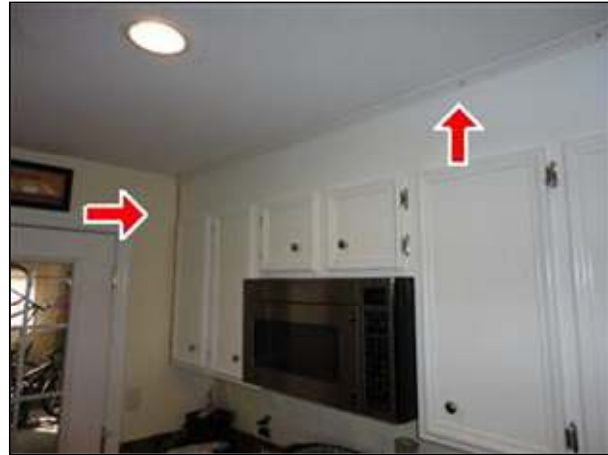
4.5 Base Cabinetry and trim at wall cabinet are unfinished at kitchen.

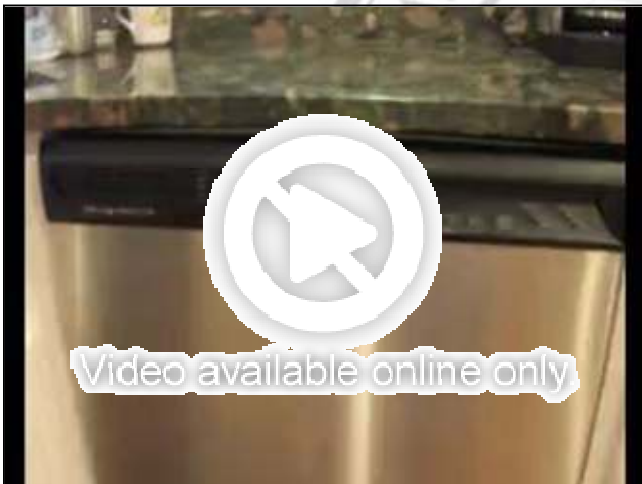
4.9 Item 1(Video)

4.9 The dishwasher is loose and needs securing to underside of countertop (using a proper length screw). I recommend repair as necessary.

The dishwasher is loose and needs securing to underside of countertop (using a proper length screw). I recommend repair as necessary.

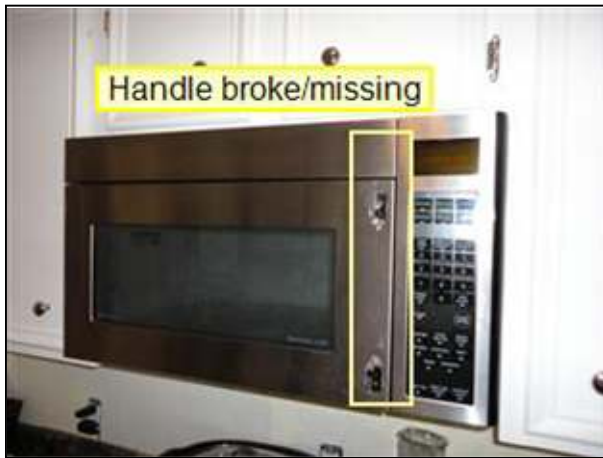
4.14 Item 1(Picture)

**4.14** The microwave door handle is broken. I recommend repair as needed.

The microwave door handle is broken. I recommend repair as needed.

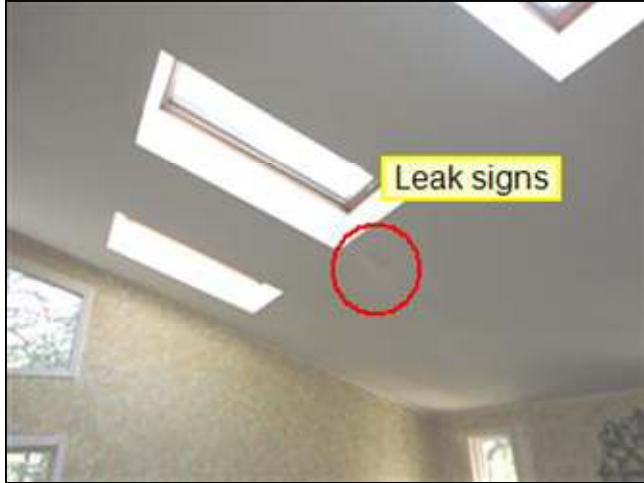
5.0 Item 1(Picture)

🔧 **5.0 (1)** The Sheetrock on the ceiling reveals a water stain indicating a leak did or still exists at the Den. Repairs are needed. A qualified contractor should inspect and repair as needed (See Roof Coverings).

(1) The Sheetrock on the ceiling reveals a water stain indicating a leak did or still exists at the Den. Repairs are needed. A qualified contractor should inspect and repair as needed (See Roof Coverings).
-

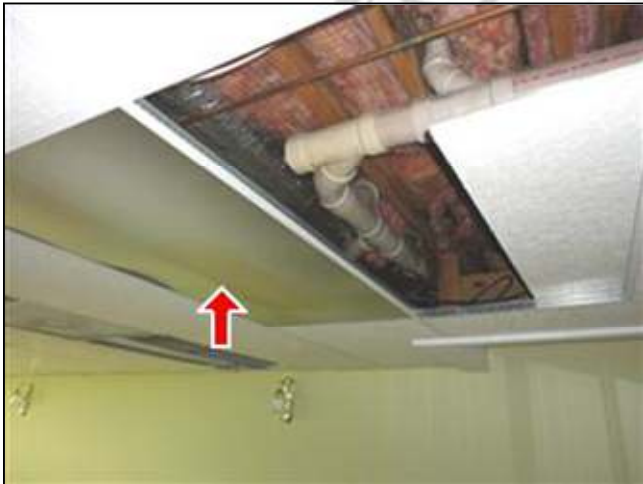
5.0 Item 2(Picture)

🔧 **5.0 (2)** Water stain on ceiling panel lower level indicates plumbing leak.

(2) Water stain on ceiling panel lower level indicates plumbing leak.
-

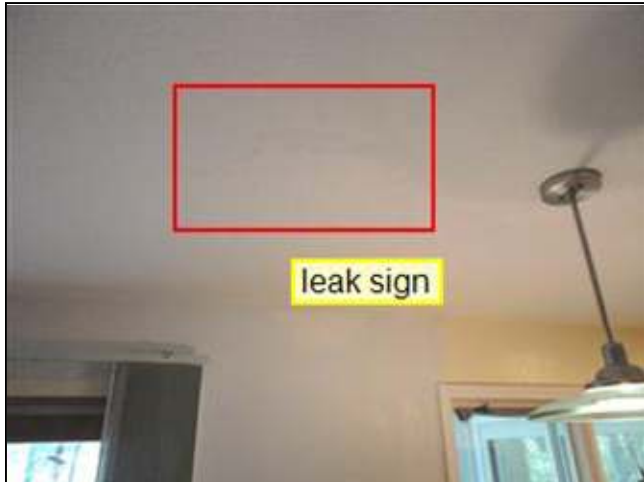
5.0 (3) The Drywall on the ceiling reveals a water stain indicating a leak did or still exists at the Dining Room. Repairs are needed. A qualified contractor should inspect and repair as needed.

(3) The Drywall on the ceiling reveals a water stain indicating a leak did or still exists at the Dining Room. Repairs are needed. A qualified contractor should inspect and repair as needed.

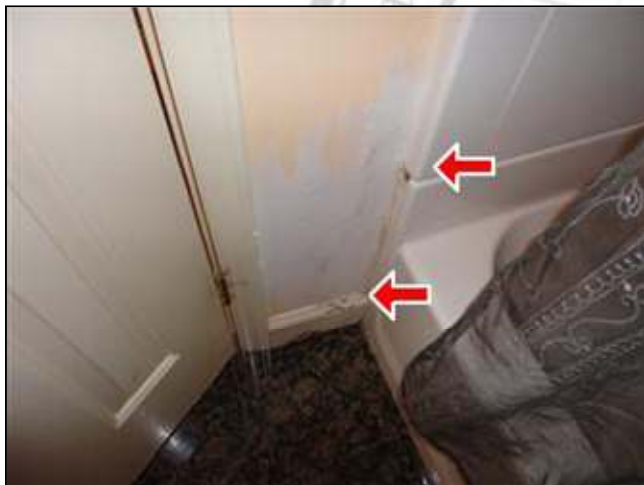
5.1 Item 1(Picture)

5.1 (2) The Wall at the bathtub is deteriorated and needs repair or replacement. The wall board and framing may need repair (not visible). I recommend repair or replace using a qualified contractor.

(2) The Wall at the bathtub is deteriorated and needs repair or replacement. The wall board and framing may need repair (not visible). I recommend repair or replace using a qualified contractor.
-

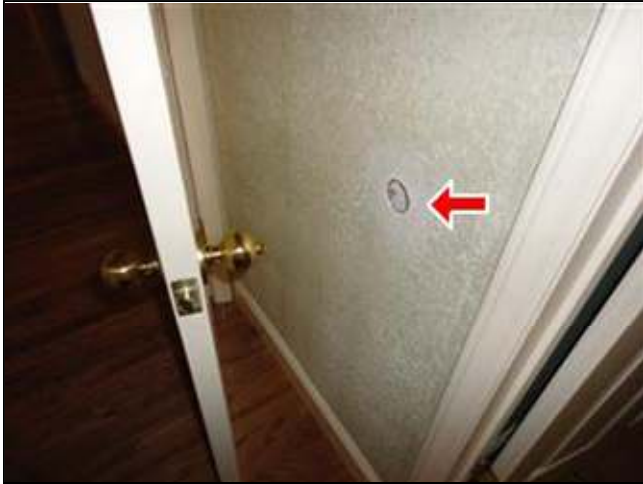
5.1 Item 2(Picture)

🔧 **5.1 (3)** The sheetrock on the wall is dented or damaged from door knob at the hallway. While this damage is cosmetic, it needs to be repaired. A qualified contractor should inspect and repair as needed.

(3) The sheetrock on the wall is dented or damaged from door knob at the hallway. While this damage is cosmetic, it needs to be repaired. A qualified contractor should inspect and repair as needed.
-

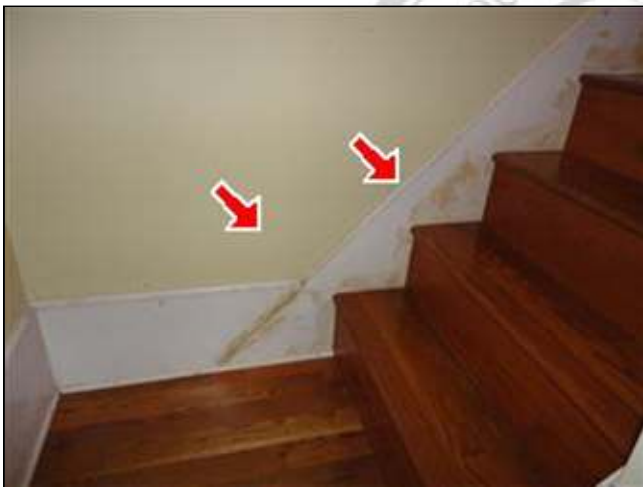
5.1 Item 3(Picture)

🔧 **5.1 (4)** Stair cover trim is unfinished needs prep and paint at stairs.

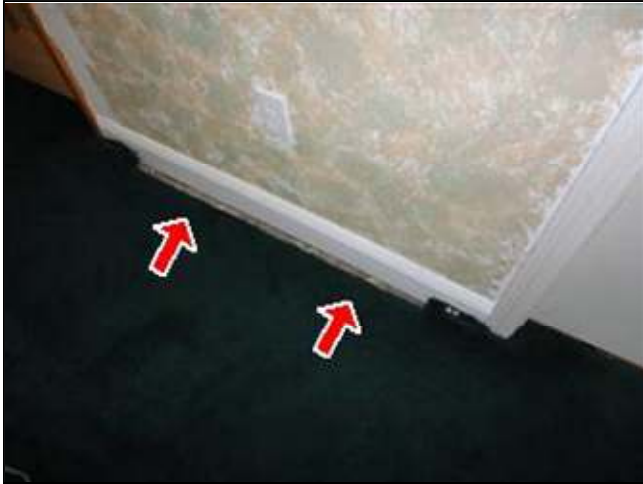
5.2 Item 1(Picture)

**5.2** Carpet is loose or cut short from where electric baseboard use to be in areas around the perimeter of the Den.

Carpet is loose or cut short from where electric baseboard use to be in areas around the perimeter of the Den.

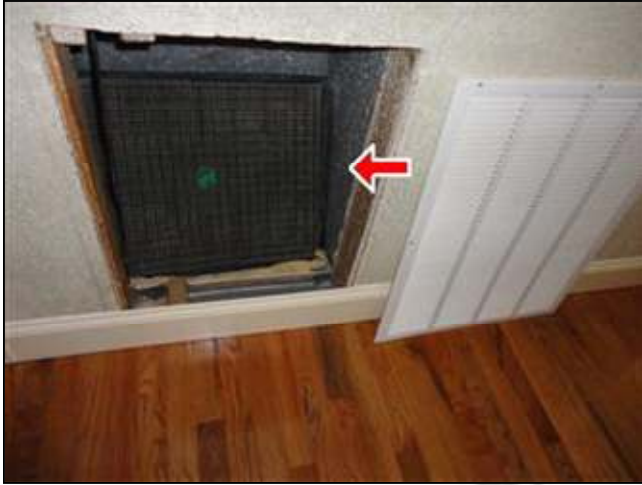
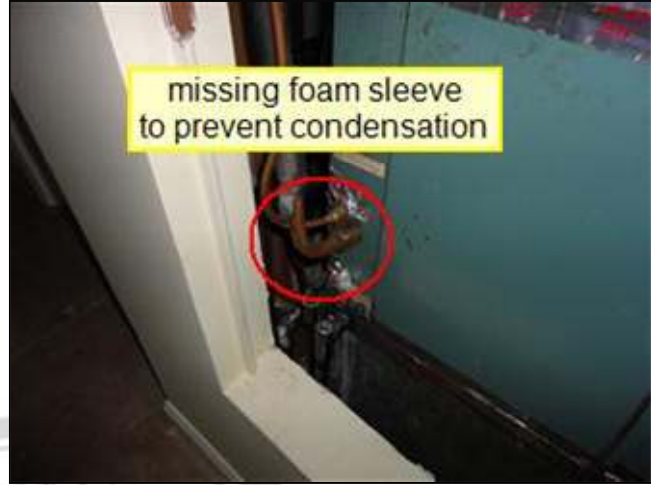
**10.3** The washable filter is dirty. The filter needs to be cleaned. Recommend foil taping the filter for a better seal. See Video. Foam sleeve missing at suction line creates condensation and drips water.

The washable filter is dirty. The filter needs to be cleaned. Recommend foil taping the filter for a better seal. See Video. Foam sleeve missing at suction line creates condensation and drips water.

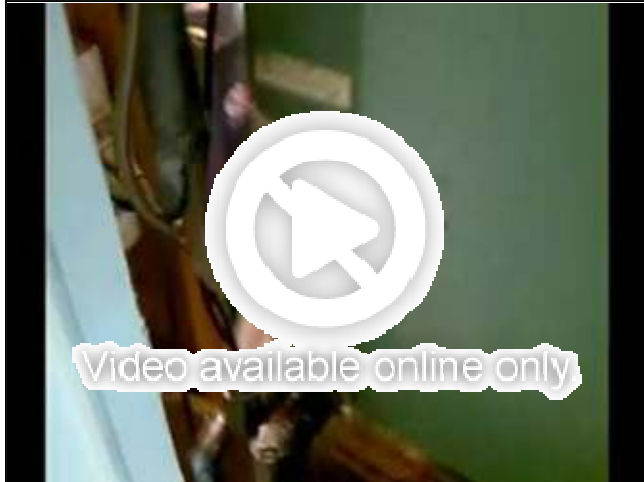
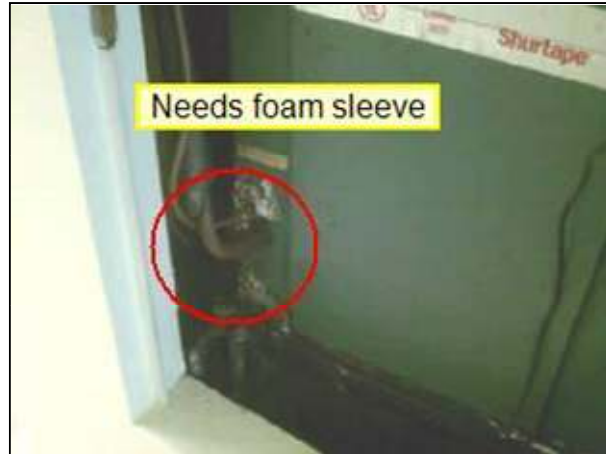
10.8 Air handler and heat pump is old but appears to be working properly. Foam sleeve on suction line is not covering copper line and condensation can drip.
